Damage detection and health monitoring of buried concrete pipelines

ABSTRACT: Rapid assessment of damage to buried pipelines from earthquake ground faulting is a crucial component to quickly plan repair efforts. This paper briefly reviews sensor technologies currently used for monitoring the health (i.e. assessing damage) of buried concrete pipelines. This paper also reports on the first of a four-year study aimed at developing rapid, reliable, and cost-effective sensing systems for health monitoring of buried concrete pipelines. The study includes testing of buried concrete pipelines in a large-scale facility that is capable of simulating earthquake ground faulting. Two modes of failure were identified in the first pipeline test, which were compression and bending at the pipeline joints closest to the fault line. As a result future research aimed at advancing sensing technology will likely focus on the behavior of the joints.

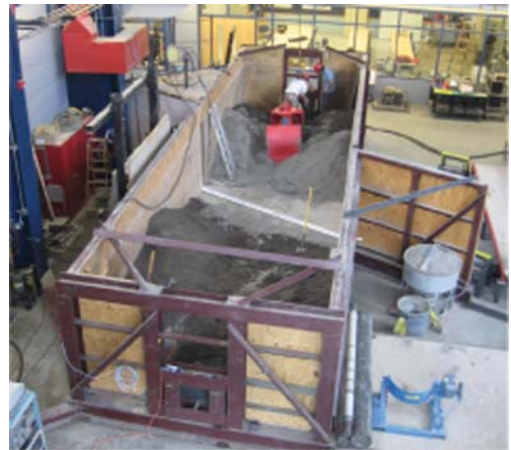
The pipeline test basin, shown in Figure 1, consists of a 11.7-meter long by 3.4-meter wide by 1.9-meter deep box, having a transverse fault oriented at an angle of 65 degrees relative to the longitudinal axis of the basin. The basin is able to accommodate a pipeline that is fixed to the ends of the test basin and buried with granular backfill. To simulate earthquake induced permanent ground displacement, one half of the basin is moved laterally parallel to the fault line using two large hydraulic actuators placed between the basin and a reaction wall, while the other half of the basin remains stationary. The box can be displaced in either direction, causing the pipeline to be put in axial compression or tension.

Figure 1. Pipeline test basin at Cornell University.

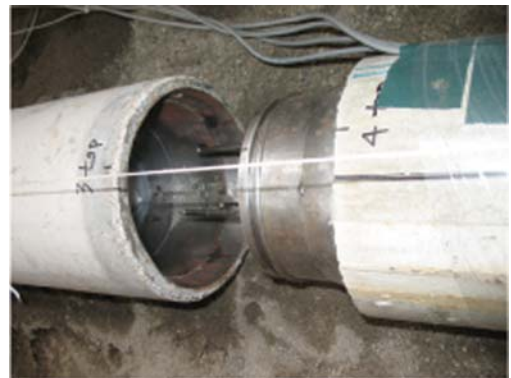
Figure 2. Typical bell-and-spigot connection between two pipe segments. The three potentiometers shown inside the pipe were used to measure displacement and rotation at the joint.

Fifteen 90-centimeter long pipe segments were fabricated at the Materials Engineering Lab at Purdue University. The pipe segments consist of a thin-walled (0.8 mm) steel tube covered by a concrete shell with steel rebar. Thirteen pipe segments were required to span the entire length of the test basin. The segments were connected by bell-and-spigot connections, shown in Figure 2. The segments were placed such that the center segment bisected the fault plane.

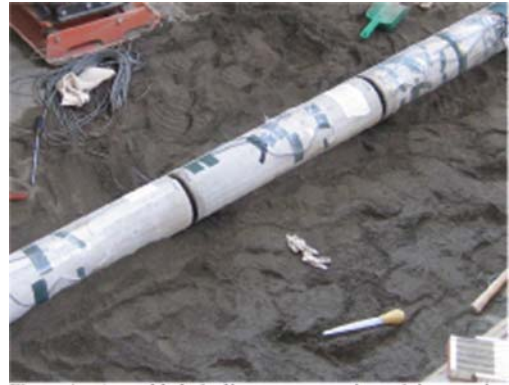
The pipeline was assembled inside the test basin working from one side of the basin to the other. Once the entire pipeline was assembled (Figure 4), the gaps between segments were grouted using mortar with 50% aggregate and a water-cement ratio of 0.5 produced using ASTM Type I/II Portland cement. Given the narrow joints, a 0.5% high range water reducer (by weight of cement) was used as needed to improve the flowability of the grout. Plastic sheets or “diapers”

Figure 4. Assembled pipeline segments prior to joint grouting. Grout was poured in the annular space shown at each joint location.

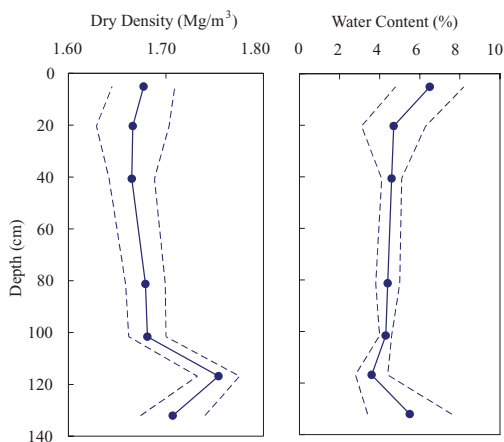
The in situ dry density and water content are shown in the depth profile in Figure 5. Each data point in the figure represents the average value for the lift. The data indicate relatively consistent properties within the soil placed above the bottom of the pipeline, which was located at a depth of about 115 cm. The average dry density in this zone was about 1.67 Mg/m^3 , and the average water content was about 5%. These values indicated an average relative compaction of about 80%, relative to the modified Proctor test. The soil located below the pipeline had a higher density due to foot traffic while the pipeline was being assembled.

Figure 5. Profile of dry density and water content of the backfill soil averaged within each lift. The dashed lines indicate \pm one standard deviation.

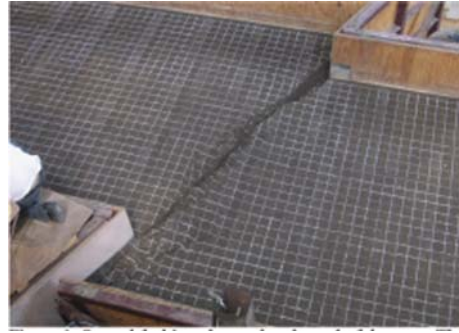
Earthquake induced permanent ground displacement was simulated by displacing one half of the test basin parallel to the strike of the fault plane. The box was configured to put the pipeline in compression as half of the basin was slowly displaced. The box was displaced at a constant rate of 0.5 cm/s to a maximum displacement of 1.22 m . The test was paused at 15-cm intervals for a period of 60 seconds. This was done to allow more controlled observation of the test and to investigate possible stress relaxation phenomena. The ground deformation at the completion of the test is shown in Figure 6.

Figure 6. Ground faulting observed at the end of the test. The gridlines shown are spaced at approximately 10 cm .

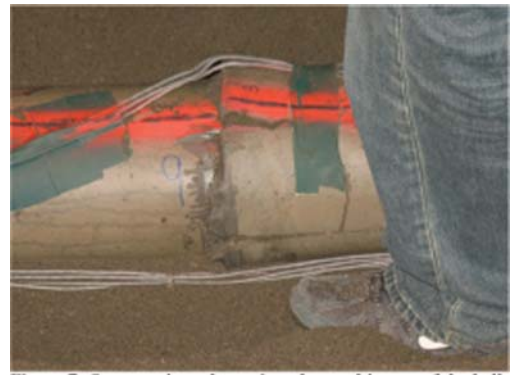
Figure 7. Compressive telescoping observed in one of the bell-and-spigot joints adjacent to the fault plane.

the test, large compressive loads caused the spigot to telescope into the bell as shown in Figure 7. However, these axial forces were not detected in the load cells at the ends of the pipeline. Therefore, it is hypothesized that the compressive loads generated in the mid-section of the pipeline were reacted by the shear forces induced at the pipe-soil interface. The telescoping-type failures occurred between the second and third pipe segments, on either side of the fault plane.

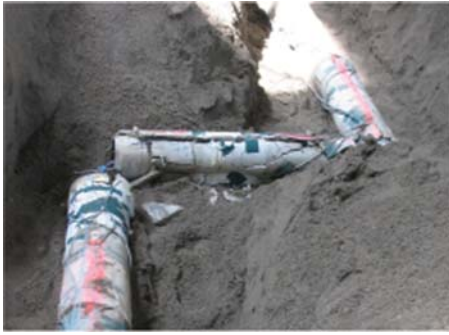
In the bending mode of failure, the un-reinforced grouted joints underwent initial micro-cracking which ultimately lead to coalesces of micro-cracks and macro-cracking and spalling/crushing of grout. The large deformations and rotation observed at the joints adjacent to the fault, shown in Figure 8, relieved any axial compressive loads that were initially developed within the pipeline.

Figure 8. Pipeline deformation observed near the fault. Note that the fault plane ran through the middle of the pipe segment shown in the center of the figure.

between segments 3 and 4. The joint between segments 6 and 7 experienced large displacements and rotations during the test, suggesting plastic behavior at the joint. In fact, at the end of the third actuated displacement (650 seconds into the record of Figure 9) the joint movement exceeded the maximum sensing range of the potentiometers. This is consistent with extreme rigid body motion of pipe segment 7; during post-testing excavation, this segment was later found to be totally separated from segments 6 and 8 (Figure 8).

The first pipeline test provided significant information on the nature and the most prominent types of damage due to faulting of segmented concrete pipelines. In the pipeline segments closest to the fault, the joints and the areas immediately adjacent to joints were damaged (see Figure 8). This leads to the conclusion that sensing in the joint areas will be most effective. Hence, sensors will be designed to monitor damage in joints and in areas adjacent to joints. Currently two groups of sensing techniques are being developed: (1) electrical sensing, and (2) Acoustic Emission (AE) sensing.
